T E C H T A L K

THERMAL STRESS BREAKAGE

This Tech Talk provides information on how to identify and minimize the causes of glass breakage. It is important to remember that neither glass manufacturers nor glass fabricators warrant glass against breakage.

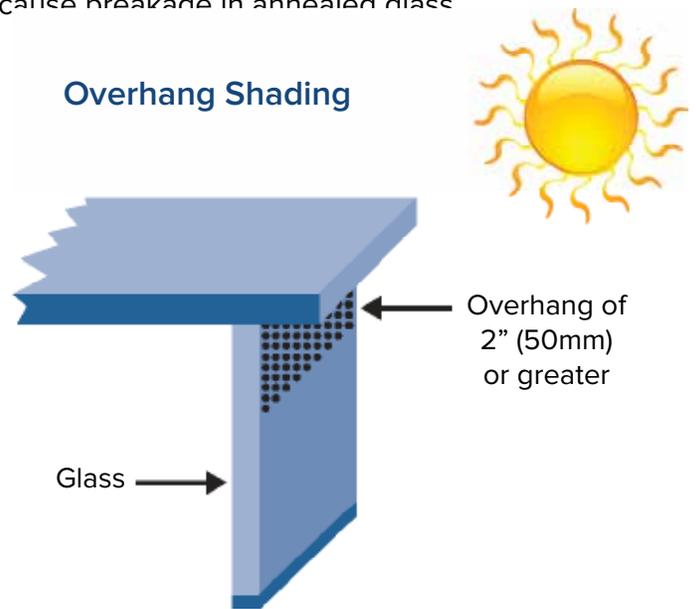
Figure 1

When the glass edge is shaded, greater thermal stresses occur, because the shadows inhibit the temperature from increasing at the glass edge (see *Figure 1*). As a result of the "colder" glass edge or the greater temperature difference between the center and the glass edge, higher tensile stresses occur, increasing the risk of glass breakage.

It is important to note that a clean cut glass edge will resist a tensile stress of ~2,400 psi. Due to the coefficient of thermal expansion of soda lime glass, a 1°F (0.56°C) temperature differential across the glass area produces ~50 psi tensile stress. Consequently, for a glass edge temperature of 70°F (21°C) and a center pane temperature of 120°F (48°C) you will have

a 50°F (27°C) differential. This results in a 2,500 psi tensile stress at the glass edge, which is sufficient to cause breakage in annealed glass

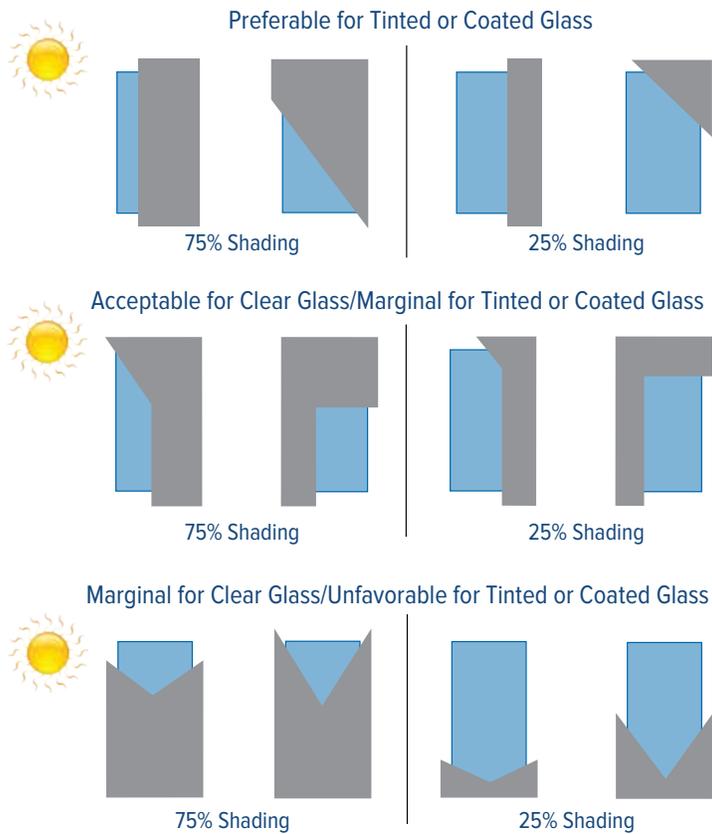
Varying outdoor shading patterns will have differ-

ent effects on glass products. For example, under marginal shading conditions, uncoated tinted glass would require heat strengthening (refer to the following illustrations).

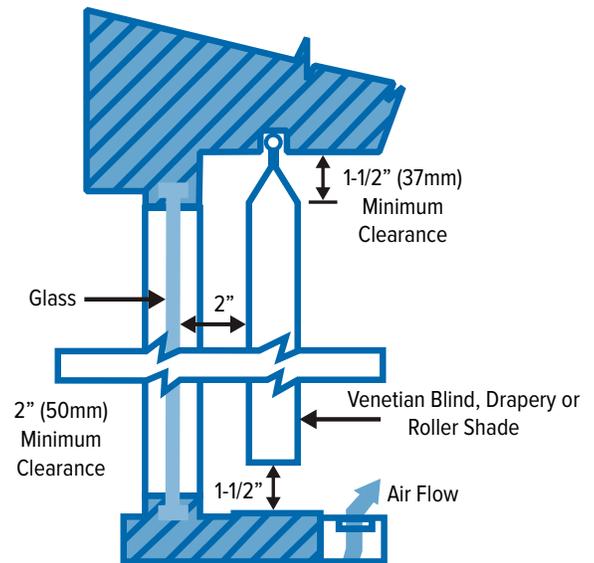
Figure 2

cast shadows onto the glass. Window treatments, such as interior blinds should also be clearly marked on the shop drawings. Heat-treated glass may be required if interior blinds are positioned in such a way that the minimum clearances cannot be met. In addition, heating and cooling registers need to be located to the roomside of any shading device. *Figure 2* illustrates the register located roomside of a venetian blind, drapery or roller shade.

Indoor Shading and Heat Duct Locations

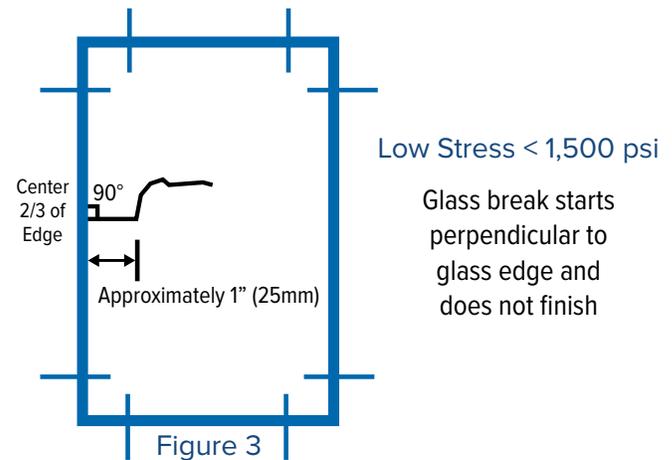
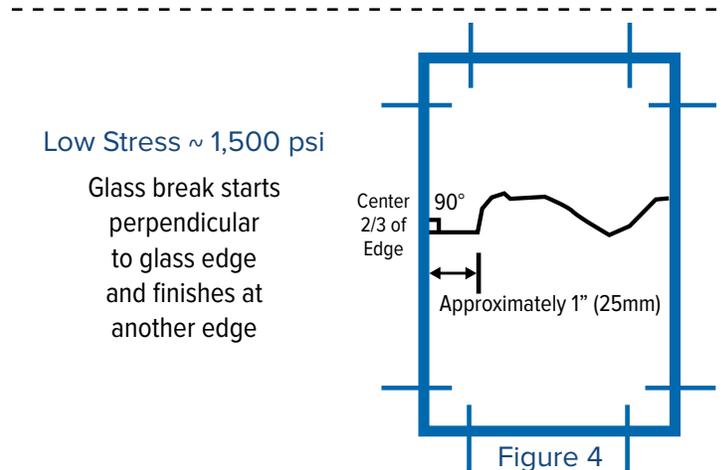
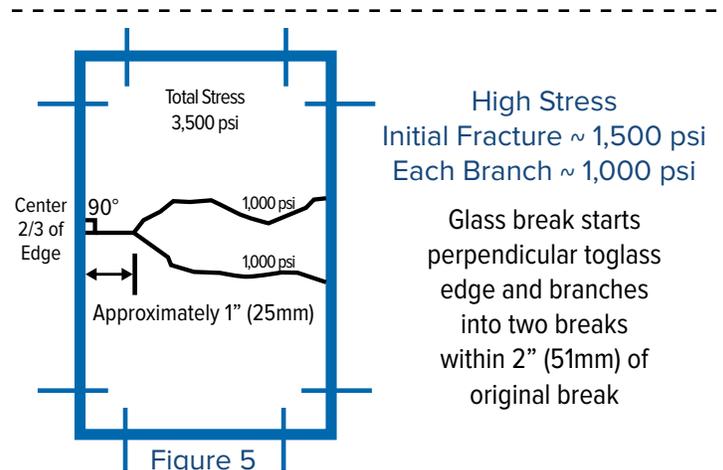
Building designs that subject glass to stresses above their design strength require heat-treated glass. Thermally-initiated fractures at stress levels below their average design strength may result from glass edge damage, which lowers the inservice glass strength (see Figures 3 through 5).

High-stress thermal breakage is an indication that the glass is incapable of withstanding the ambient thermal stresses. To minimize the risk, heat strengthened glass is required.
